ROAD STRUCTURE ASSET MANAGEMENT REPORT

City of Greater Sudbury

Keystone Bridge Management Corp.

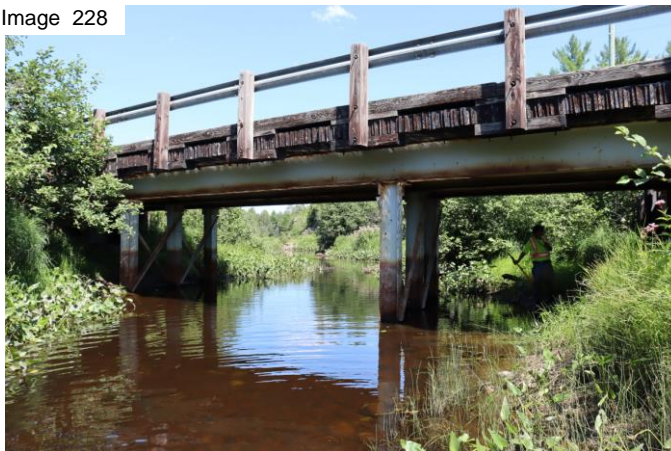
Image 228

West elevation

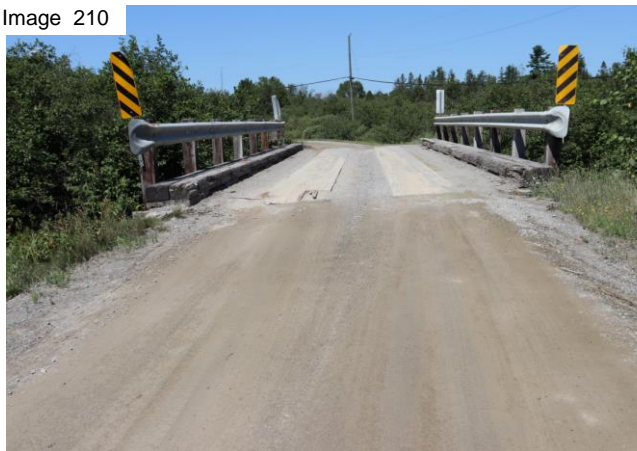
Image 210

South approach

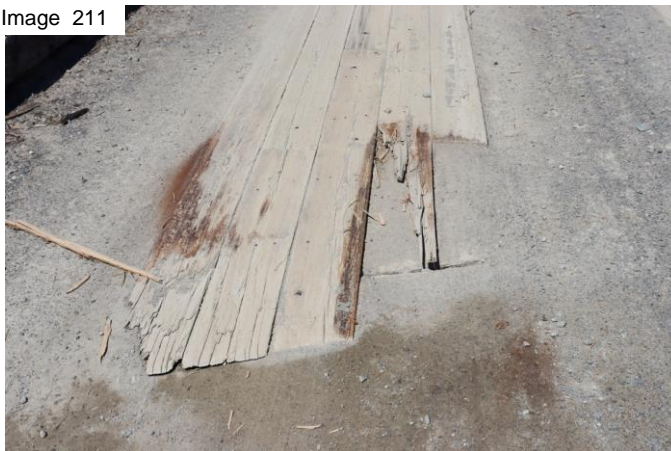
Image 211

South deck surface damaged boards

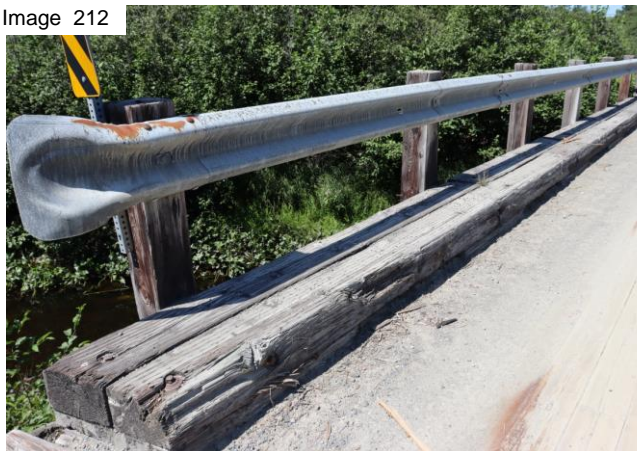
Image 212

West guide rail & curb

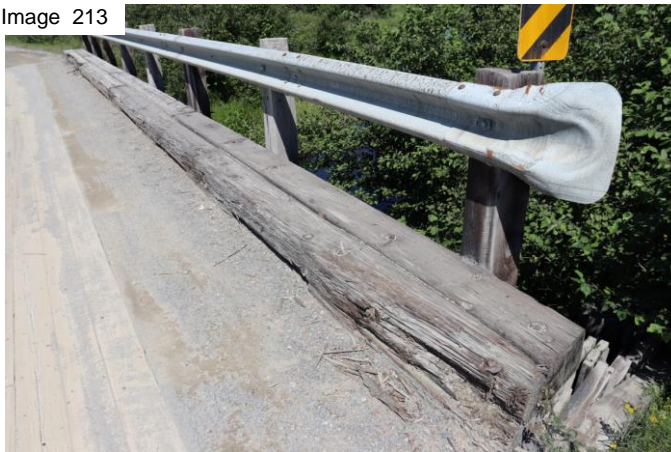
Image 213

East guide rail & curb

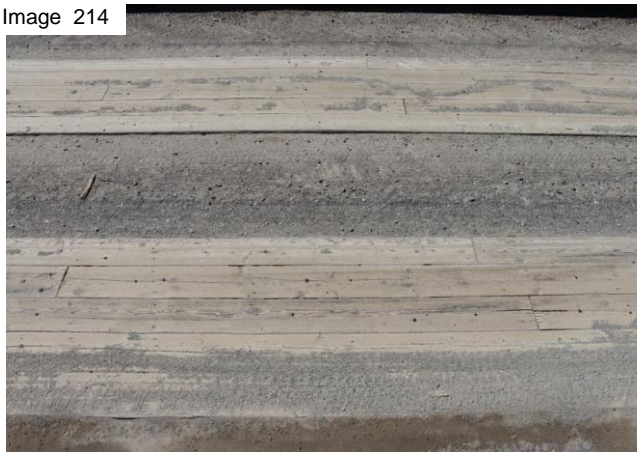
Image 214

Deck surface

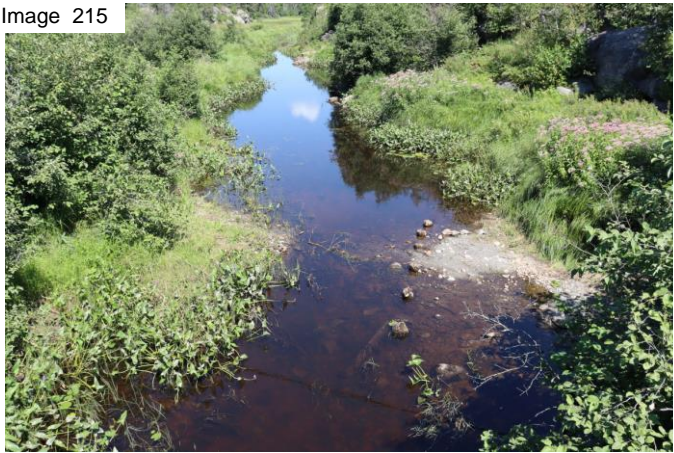
Image 215

West channel

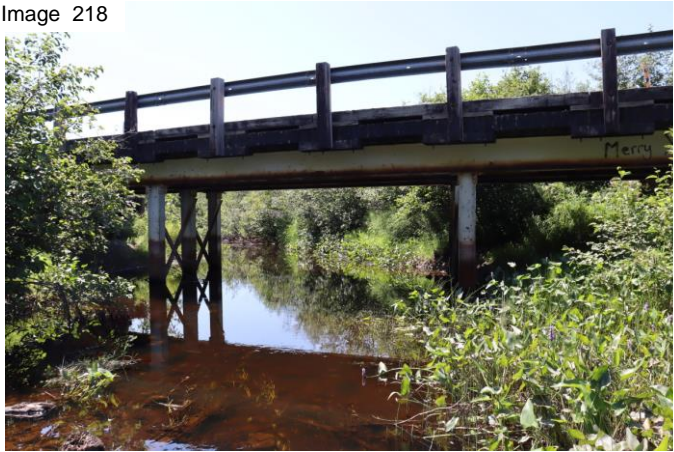
Image 218

East elevation

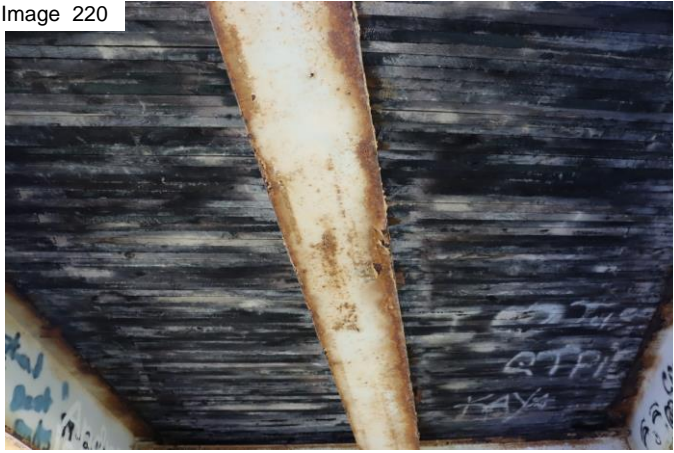
Image 220

North soffit

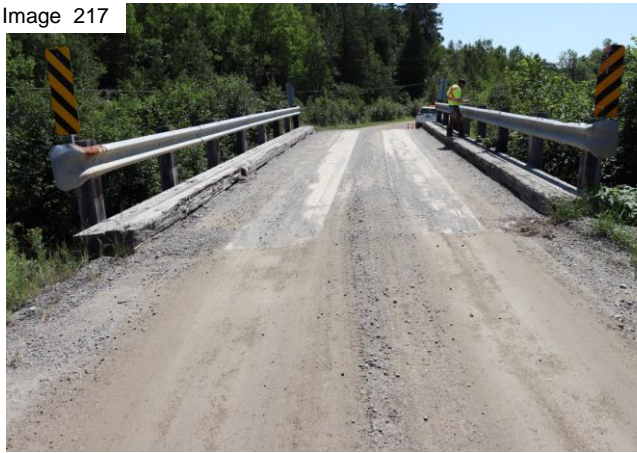
Image 217

North approach

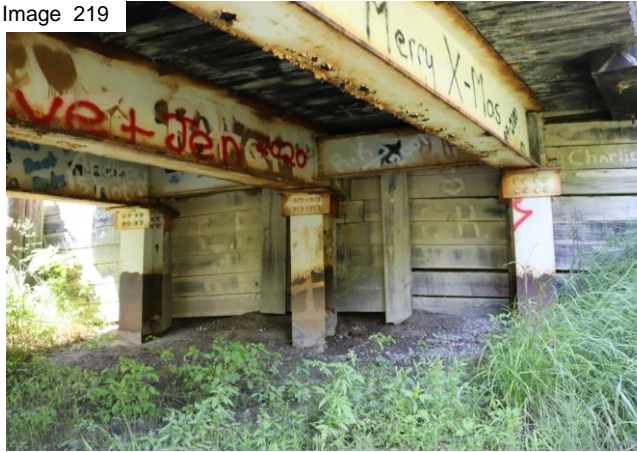
Image 219

North abutment

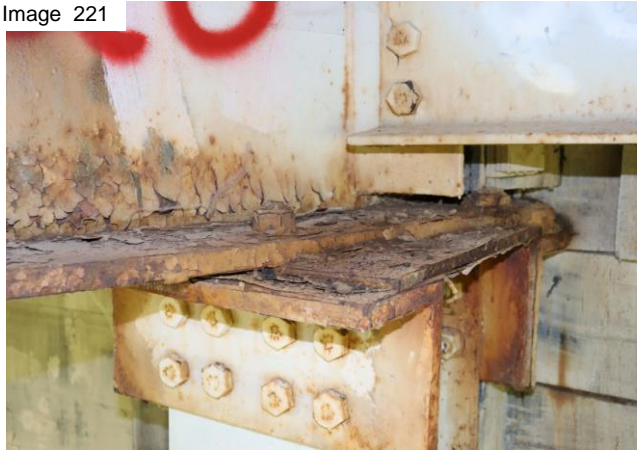
Image 221

North bearing

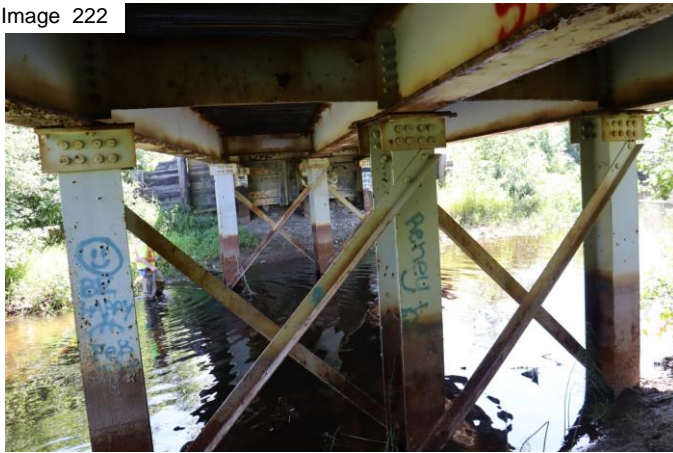
North pier

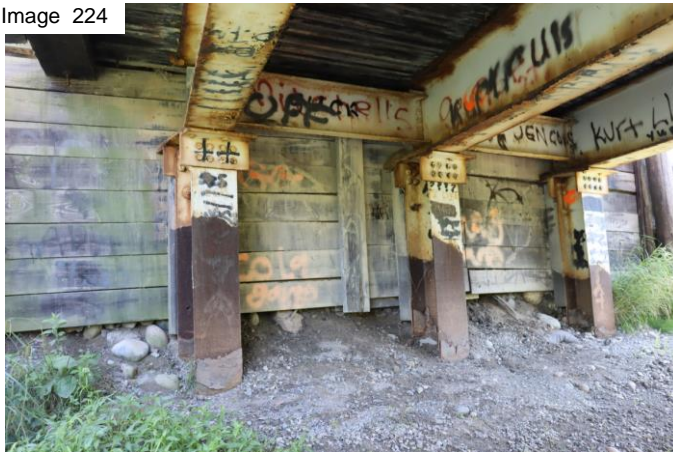
South abutment

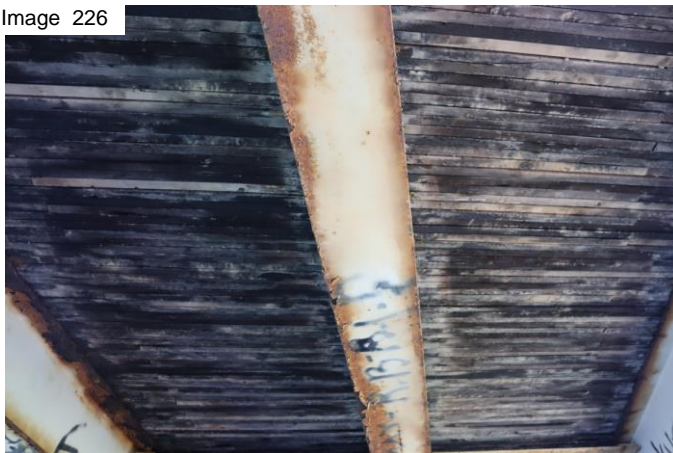
South soffit

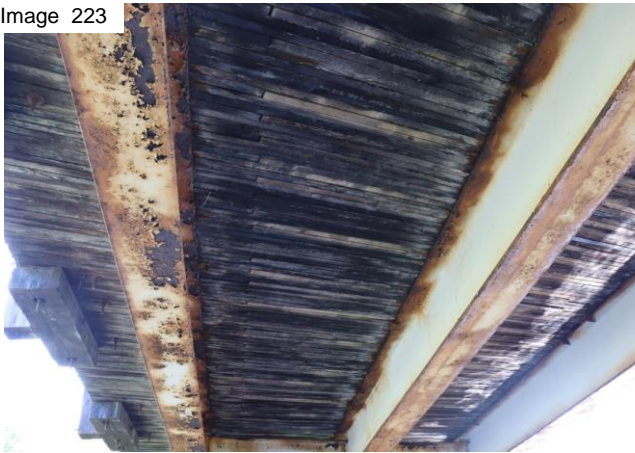
Mid span soffit

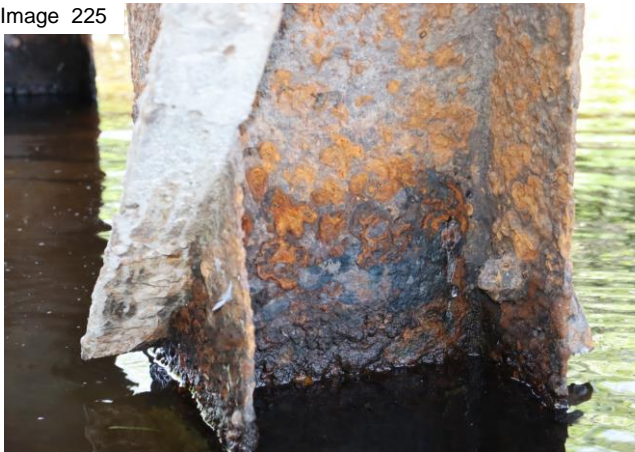
South pier pile perforation

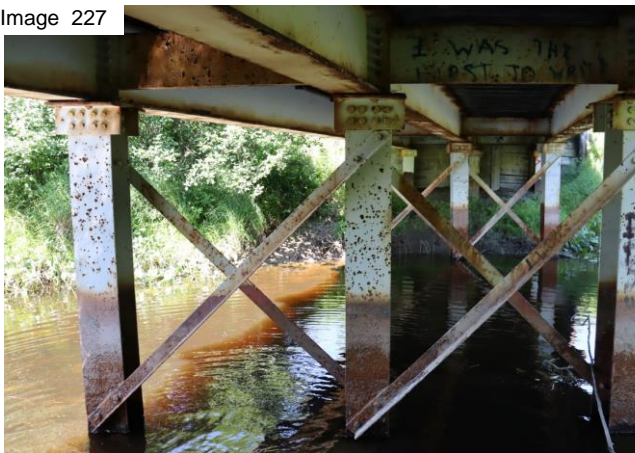
South pier
