Appendix F

Stream Morphology

Photographic Record

Junction Creek Subwatershed Study

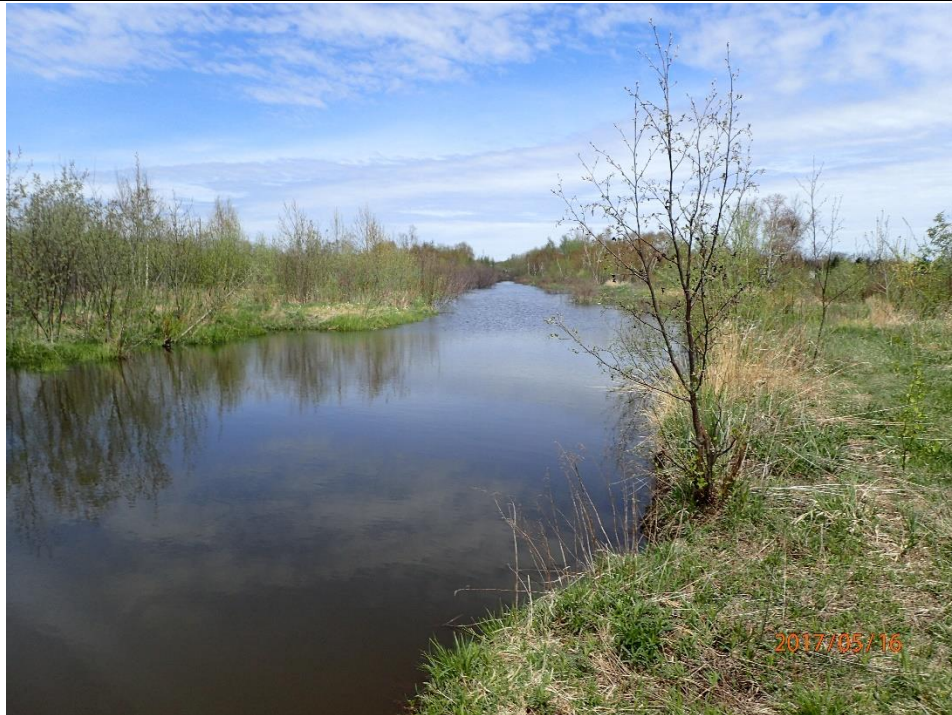
Photo
21
Reach
TJ-14

Photograph taken facing upstream.
Extensive backwatering from established beaver dams observed in lower half of reach.

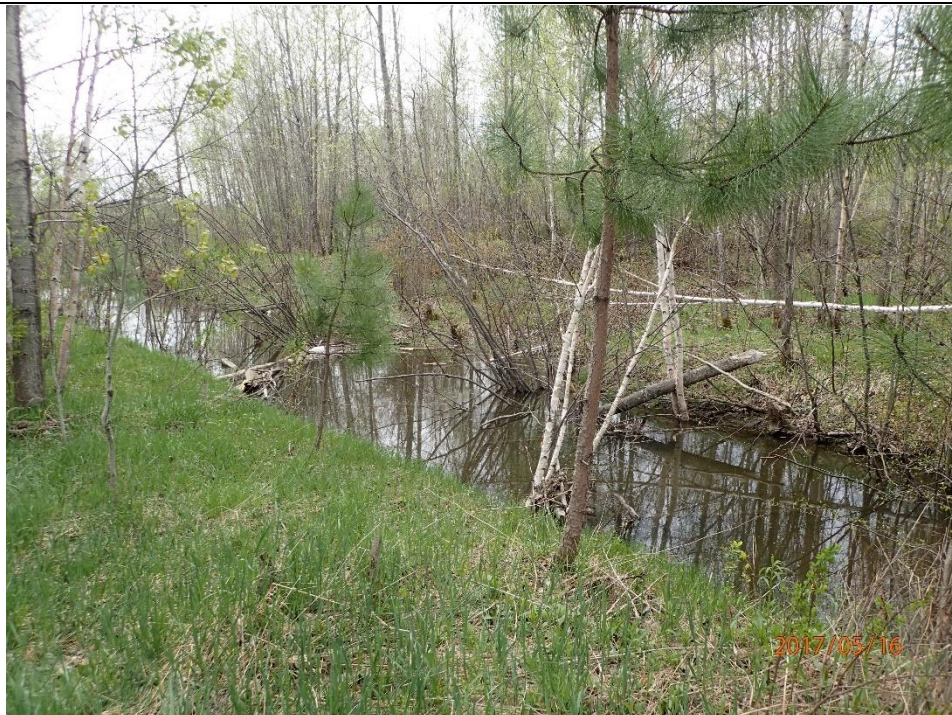
Photo
22
Reach
TJ-14

Photograph taken facing downstream.
Backwatering and leaning trees observed along top portion of reach.

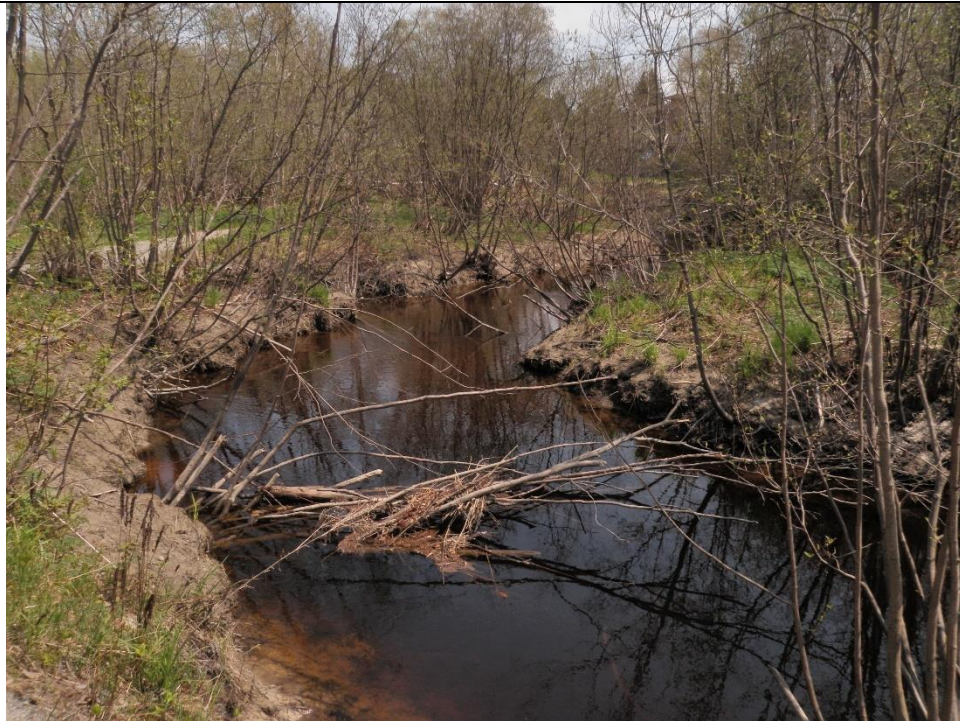
Photo
25
Reach
TJ17

Photograph taken facing downstream/ left bank.
Undercutting and slumping, leaning trees, large woody debris in channel common.

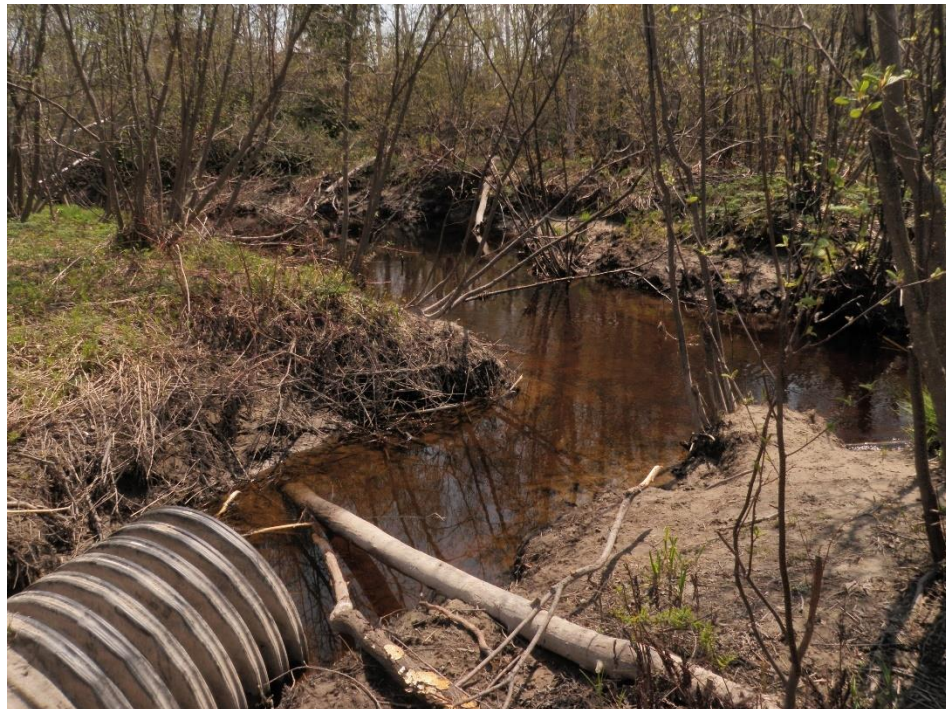
Photo
26
Reach
TJ17

Photograph taken facing downstream toward right bank.
Pipe outlets common throughout reach. Failure and erosion of right bank observed.

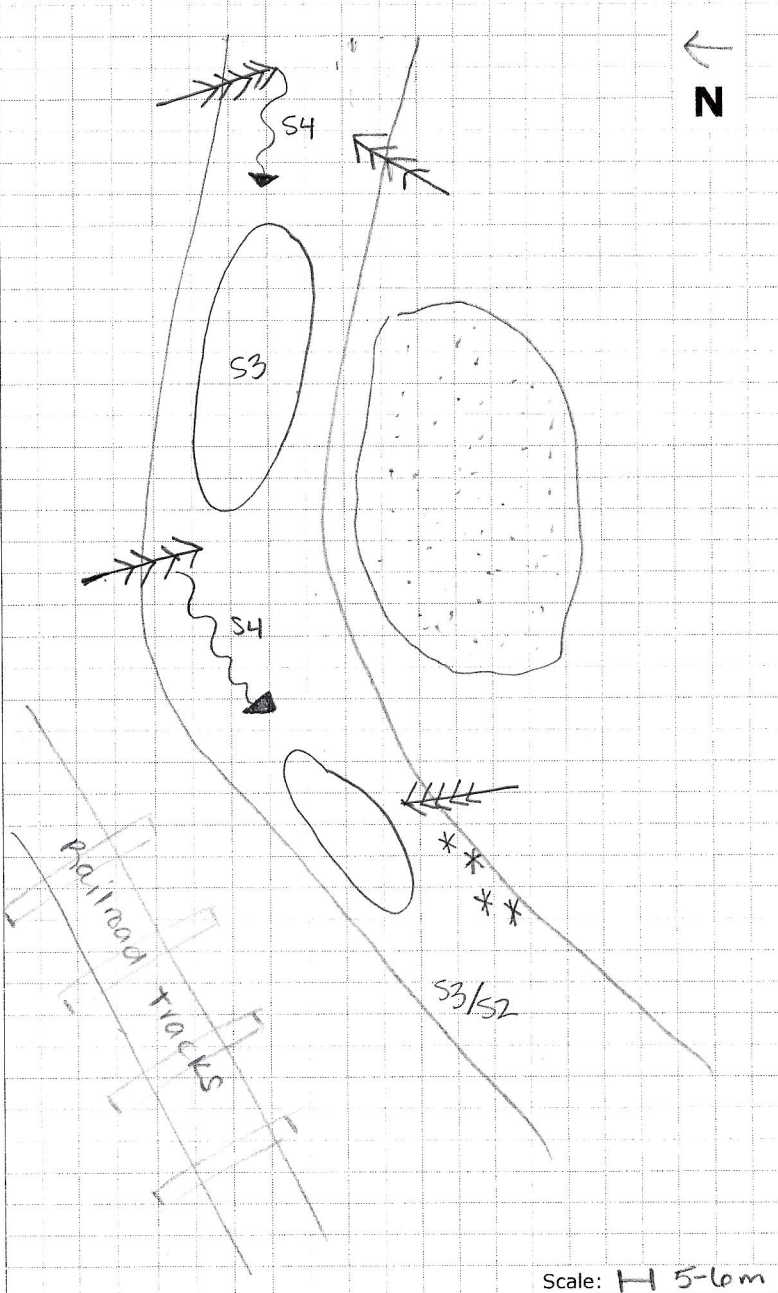
Site Sketch:

Only 2 riffles in the whole reach
