Appendix F2

Photographic Record

Junction Creek Subwatershed Study

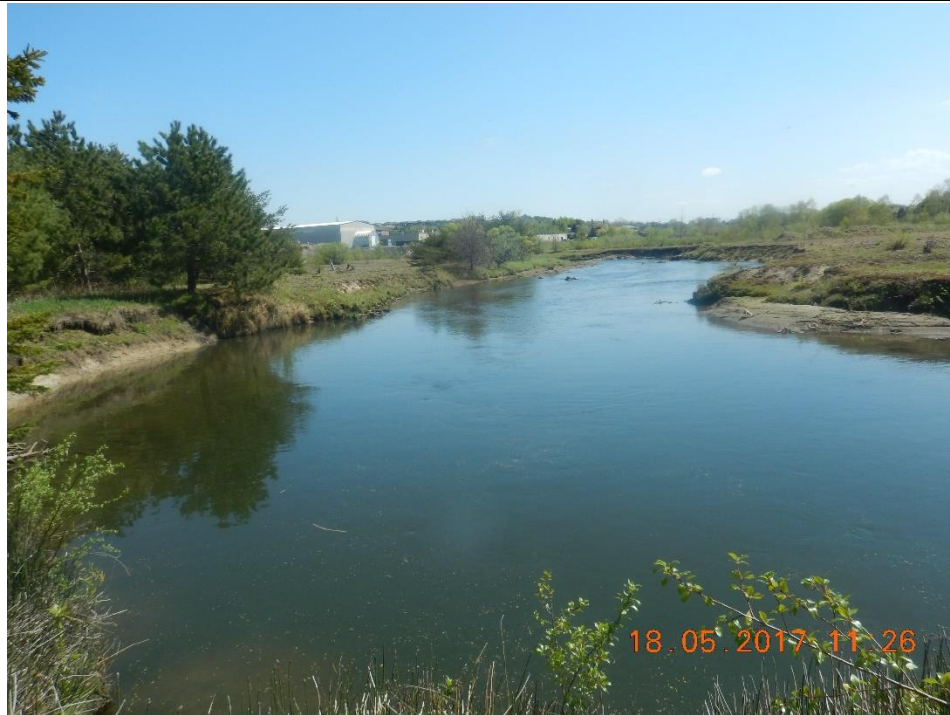
Photo
1
Reach
J7

Photograph taken facing upstream.
Point bars established on inside meander bends and bank failures on outside of bends.

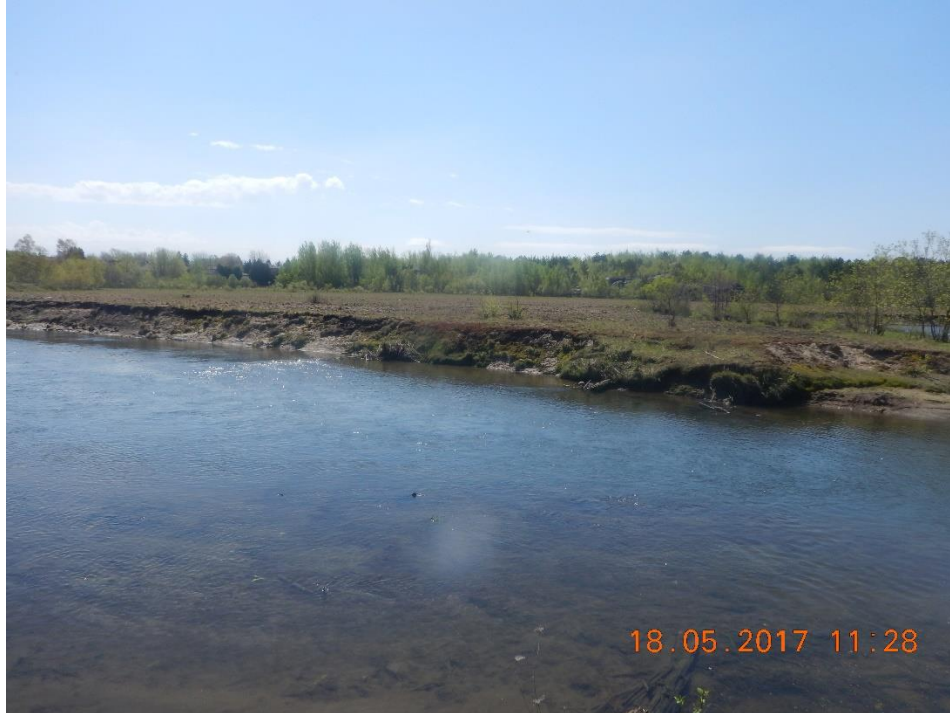
Photo
2
Reach
J7

Photograph taken facing left bank.
Rotational sliding and slumping common along banks.

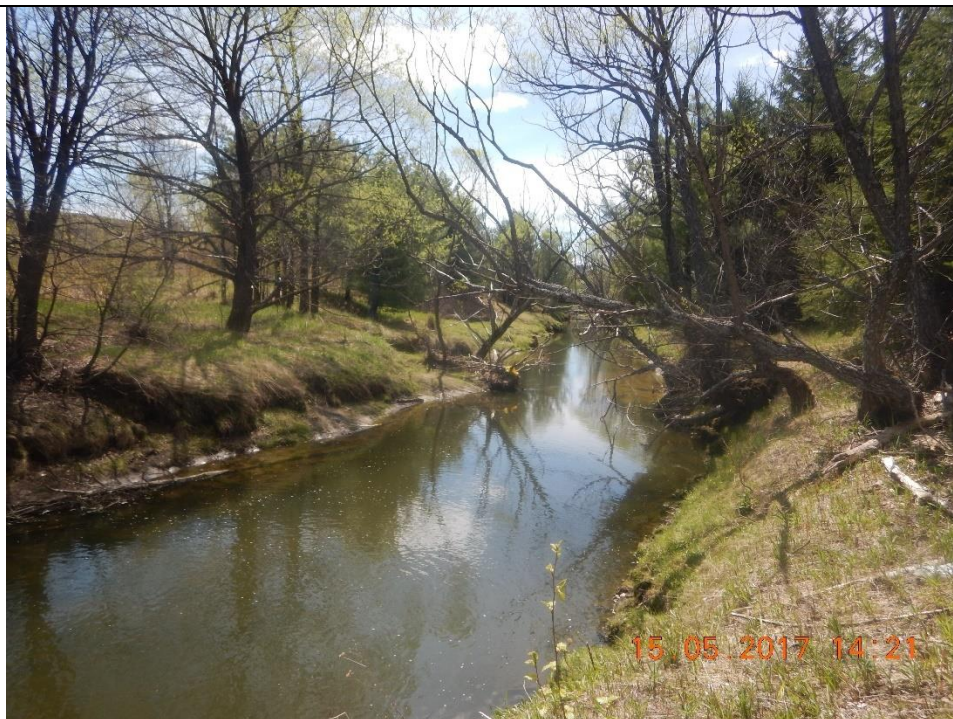
Photo
3
Reach
J8

Photograph taken facing downstream.
Undercutting and bank failures were observed, leaning trees common.

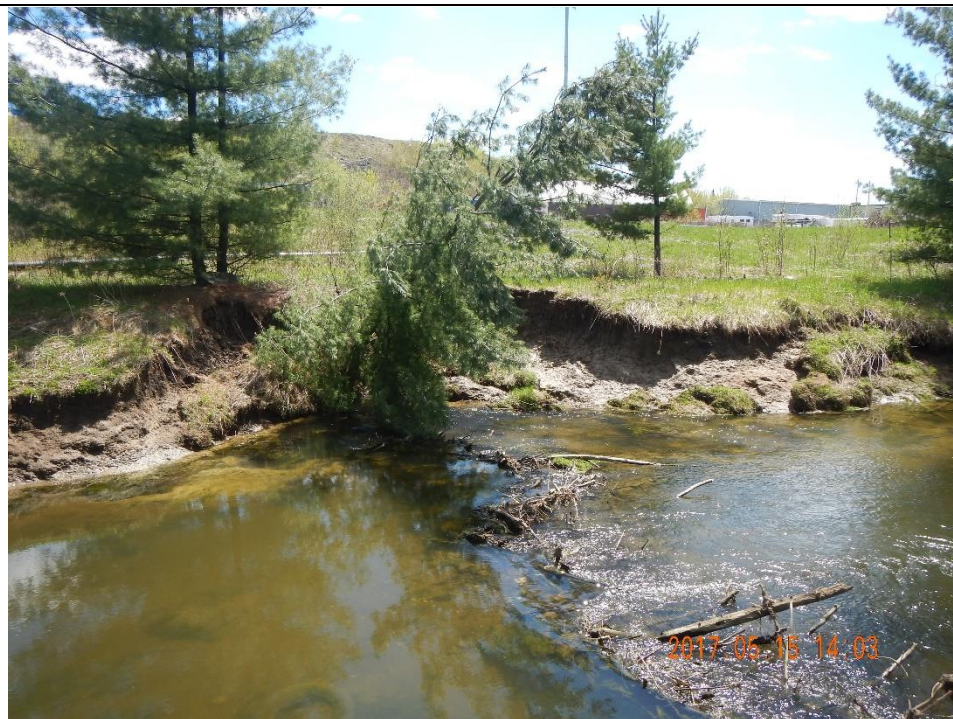
Photo
4
Reach
J8

Photograph taken facing left bank.
Rotational sliding and slumping of bank, leaning tree and woody debris in channel.

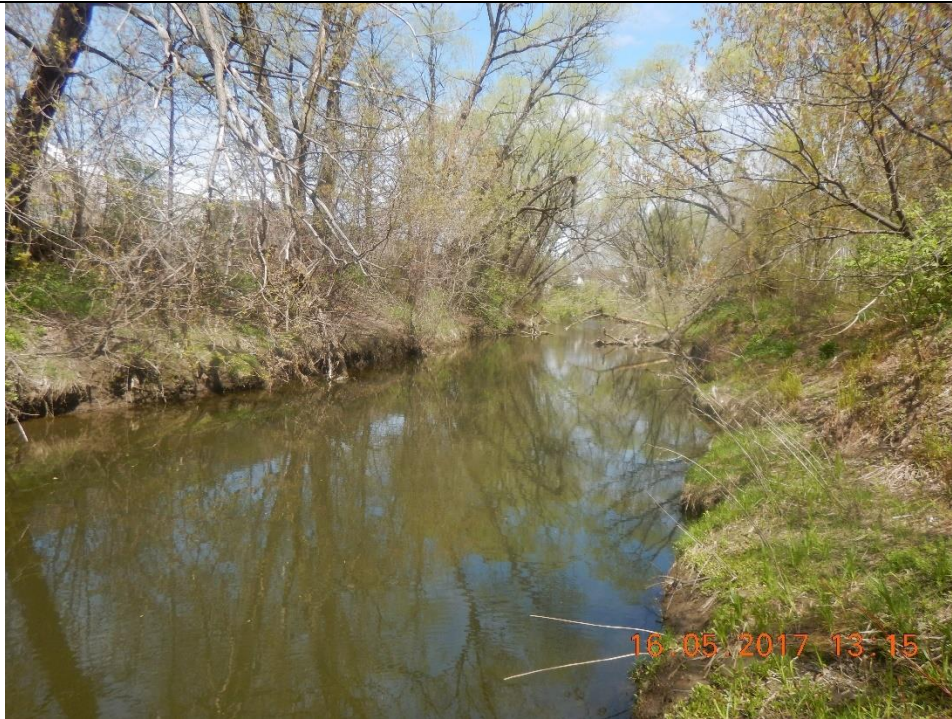
Photo
5
Reach
J9

Photograph taken facing downstream.
Woody debris in channel, leaning trees were observed.

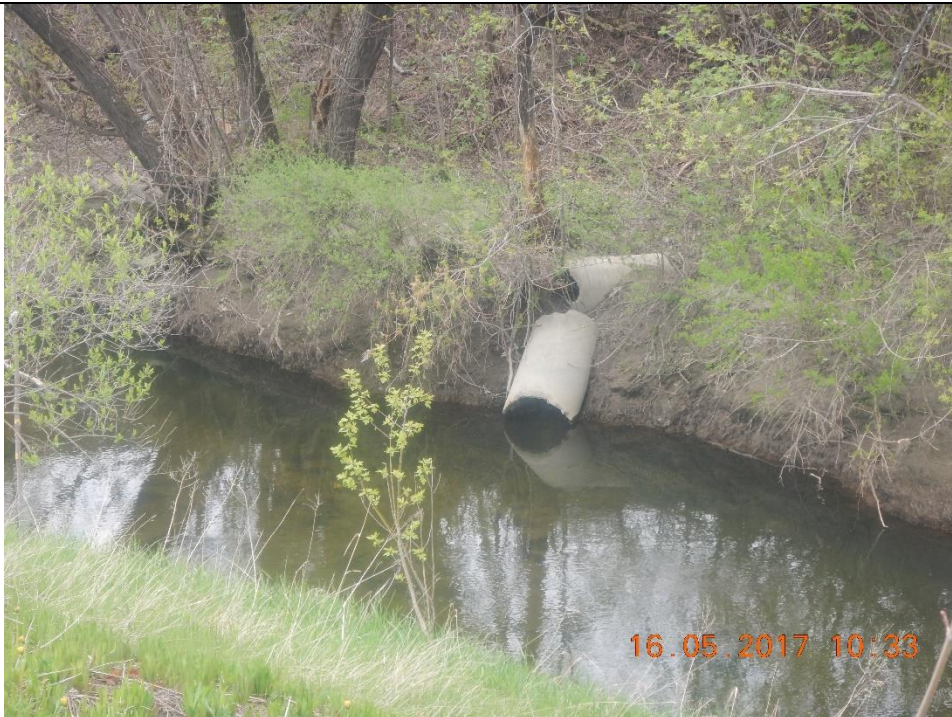
Photo
6
Reach
J9

Photograph taken facing left bank.
Undercutting of banks, root exposure, and pipe outlets common along reach.

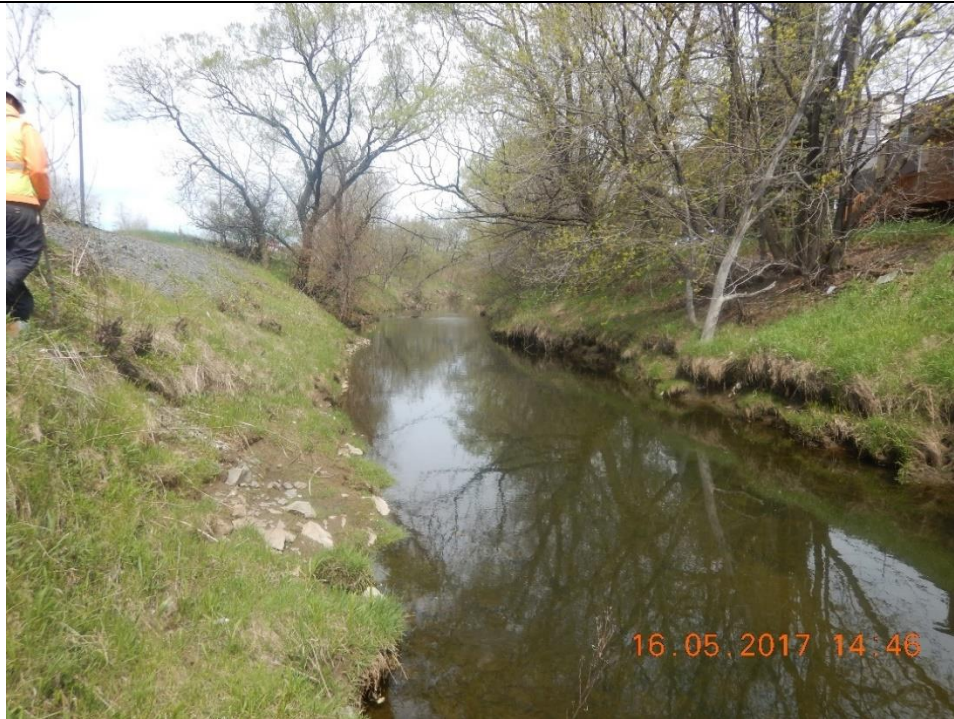
Photo
7
Reach
J10

Photograph taken facing upstream.
Undercutting, slumping, and pipe outlets common. Rip rap observed.

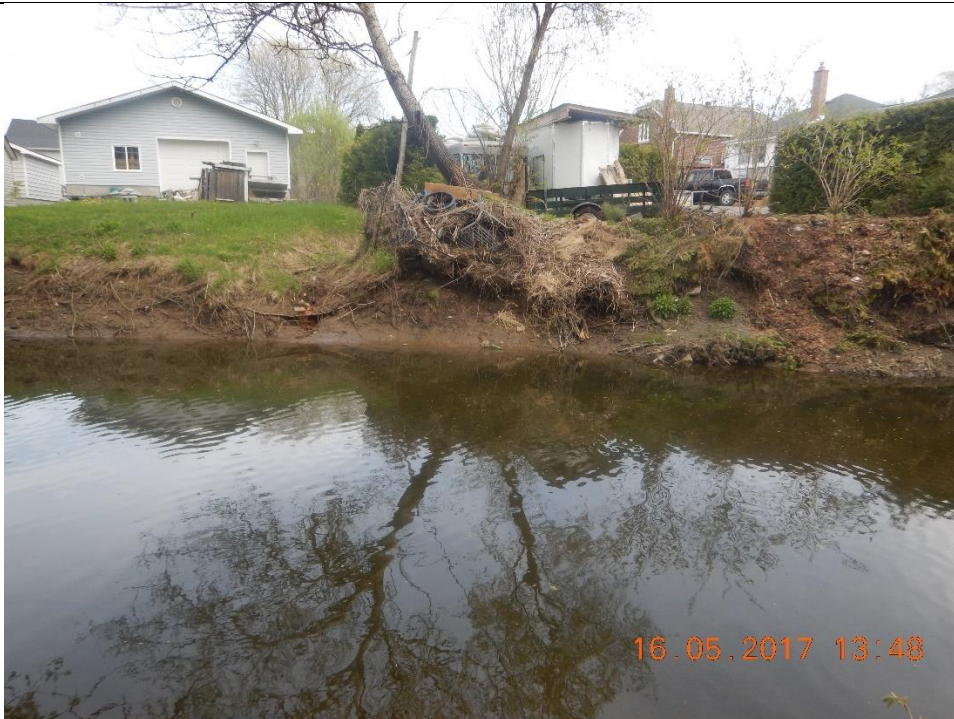
Photo
8
Reach
J10

Photograph taken facing left bank.
Bank failure present and trash line observed at property edge.

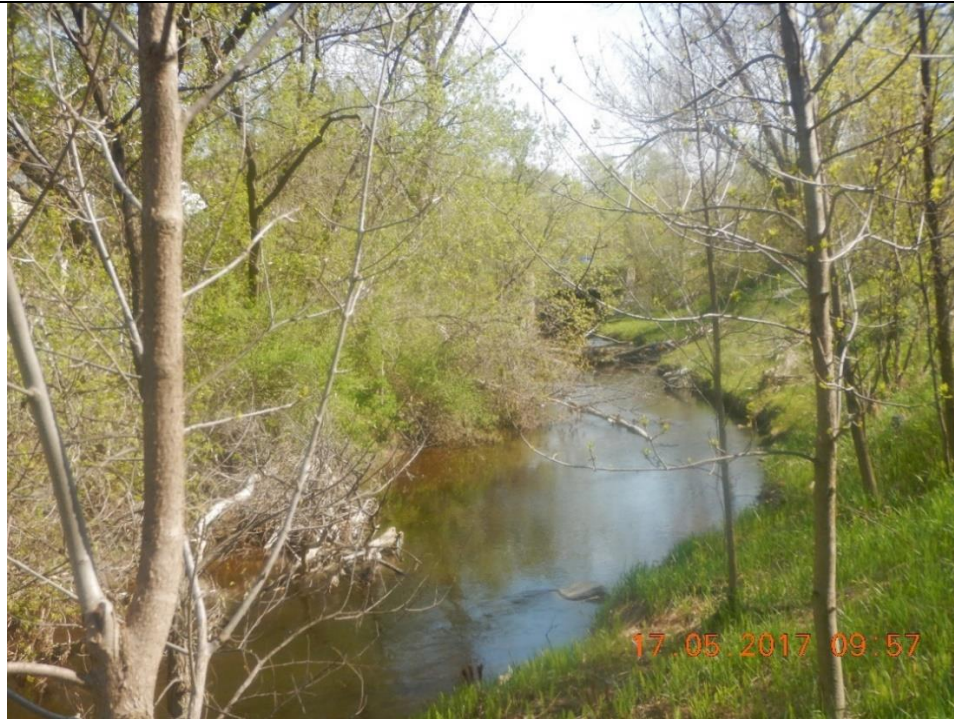
Photo
9
Reach
J11

Photograph taken facing upstream.
Undercutting, leaning trees, pipe outlets, and large woody debris were all common.

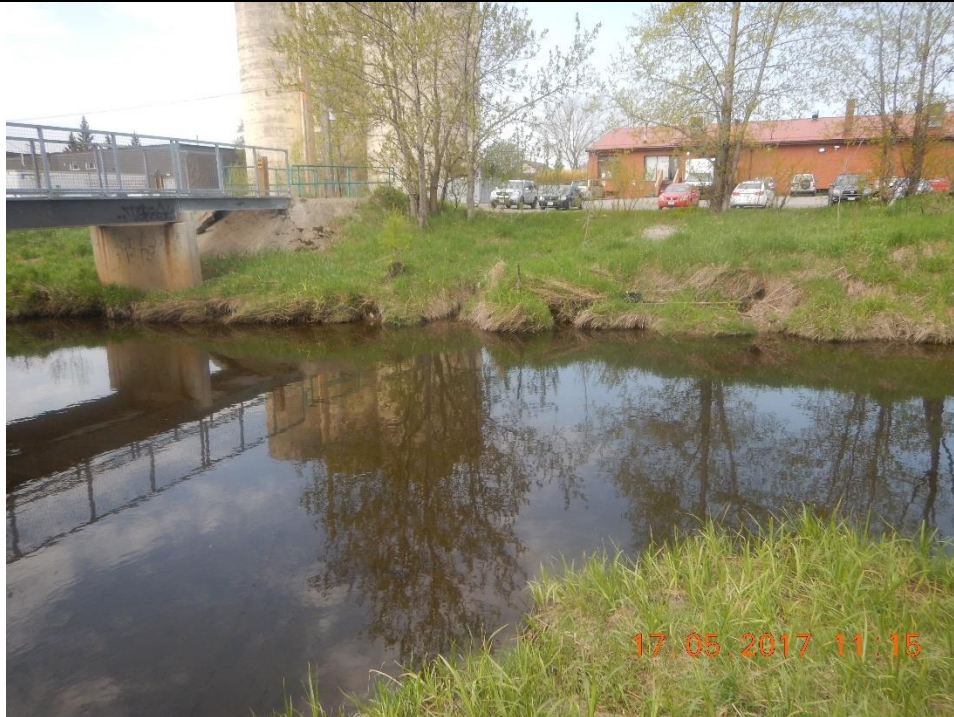
Photo
10
Reach
J11

Photograph taken facing right bank.
Fracture lines and bank failure were noted.

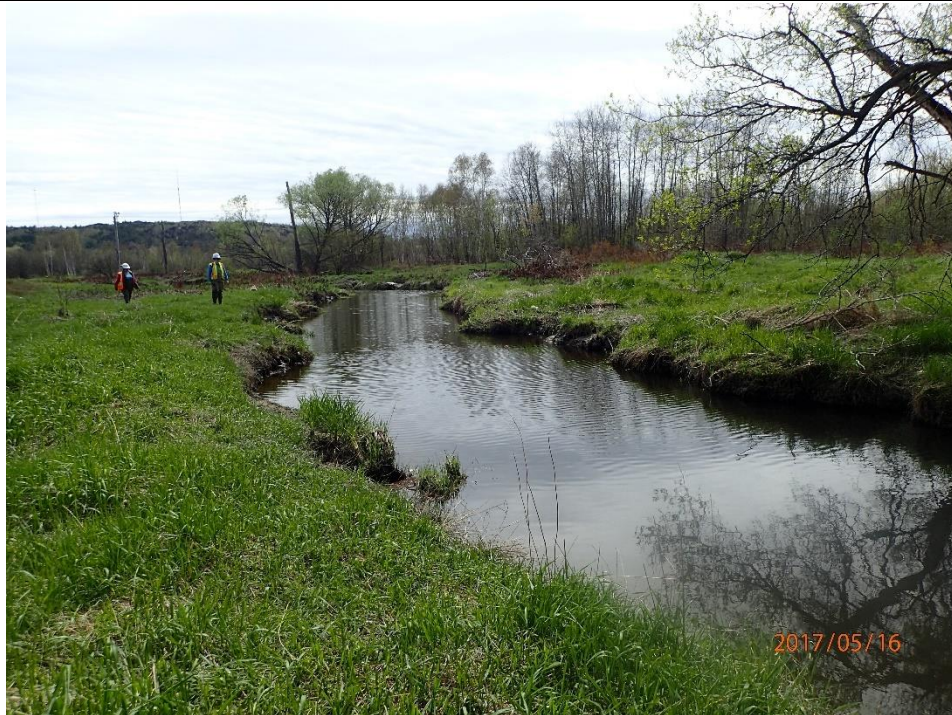
Photo
11
Reach
J13

Photograph taken facing downstream.
Fracture lines and undercutting present along banks.

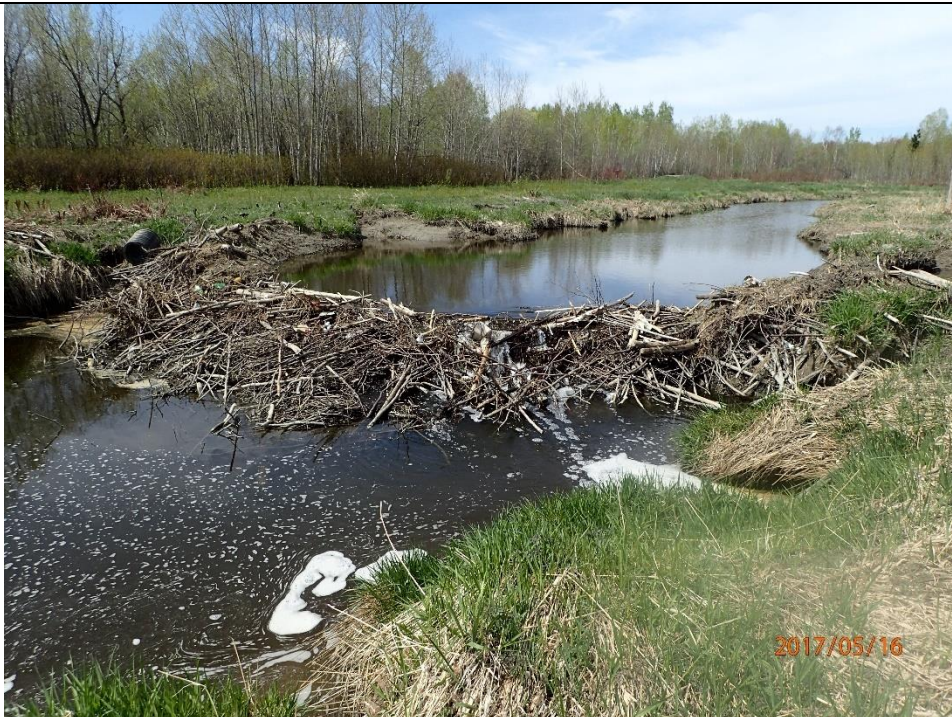
Photo
12
Reach
J13

Photograph taken facing upstream.
Established beaver dam at mid reach. Could not proceed downstream because of access.

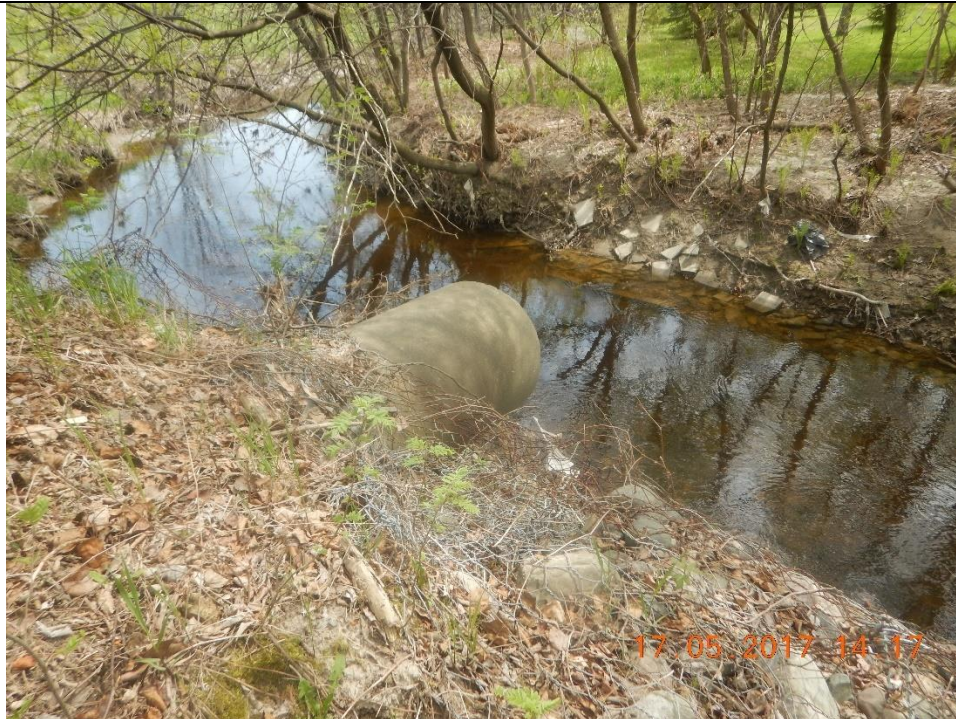
Photo
13
Reach
J14

Photograph taken facing upstream.
Exposed tree roots and rip rap observed. Pipe outlets undercutting banks were common.

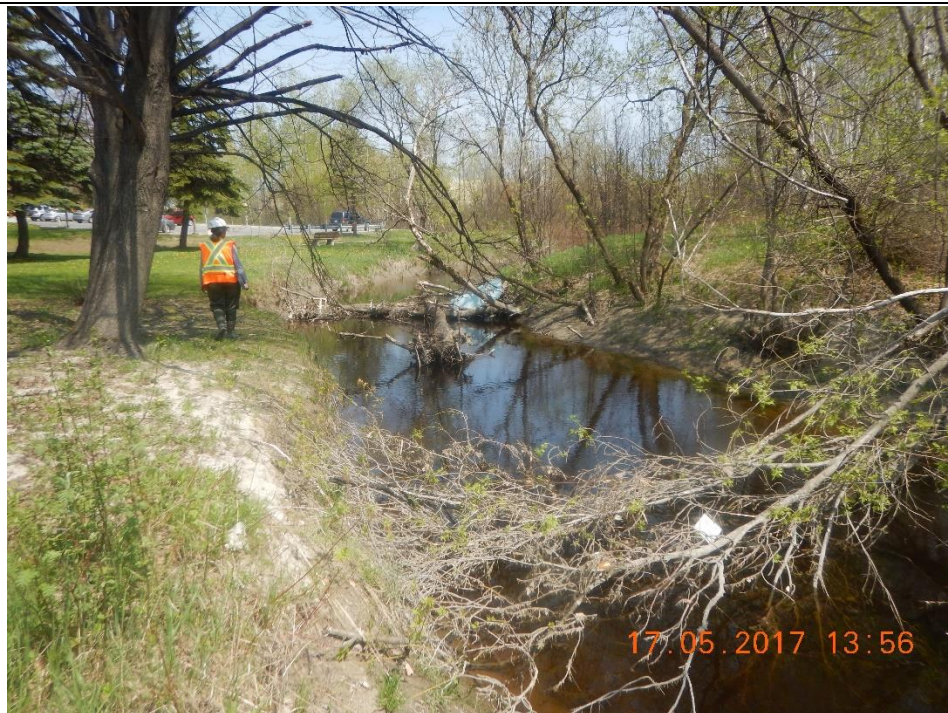
Photo
14
Reach
J14

Photograph taken facing downstream.
Leaning trees and large woody debris common throughout reach.

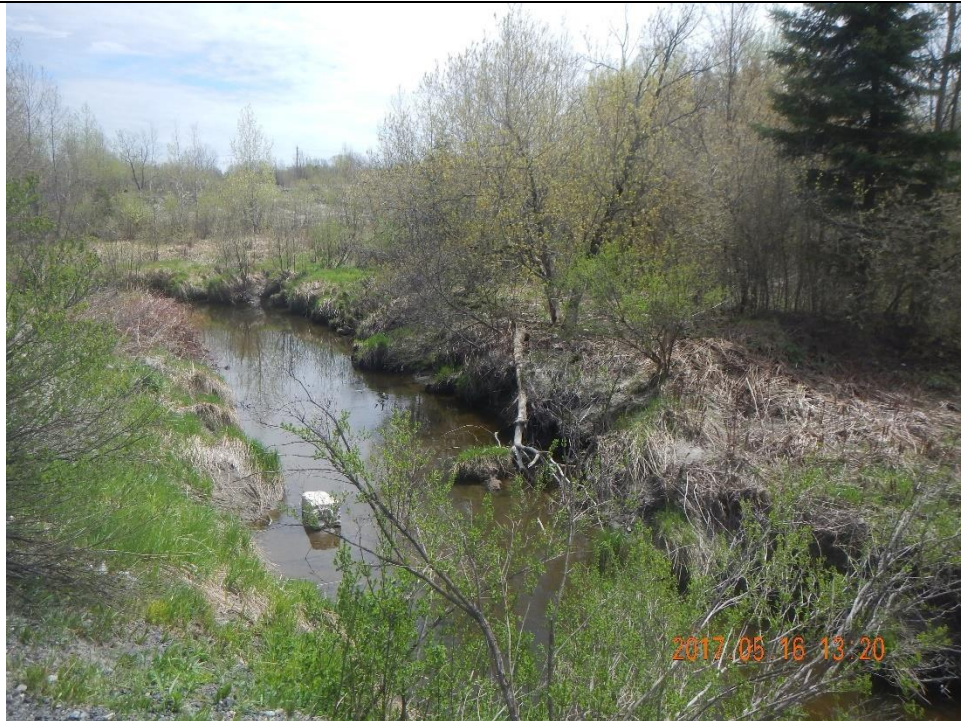
Photo
15
Reach
J15

Photograph taken facing upstream.
Bank undercutting, slumping, and large woody debris common.

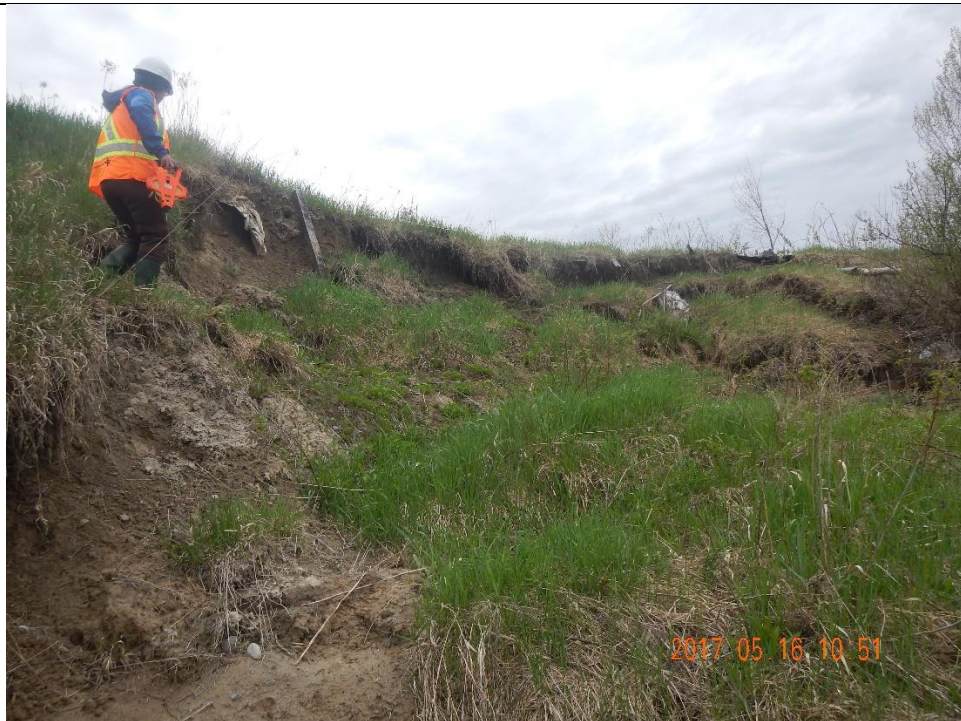
Photo
16
Reach
J15

Photograph taken facing left bank.
Large erosion scar observed.

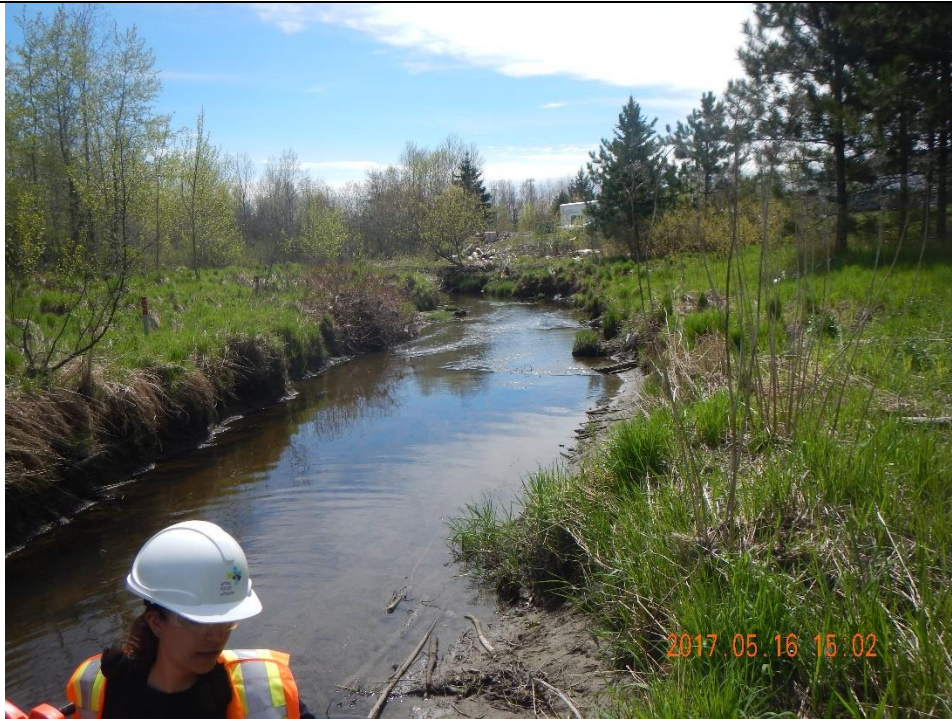
Photo
17
Reach
J16

Photograph taken facing downstream.
Slumping and bank erosion common. Woody debris observed in channel.

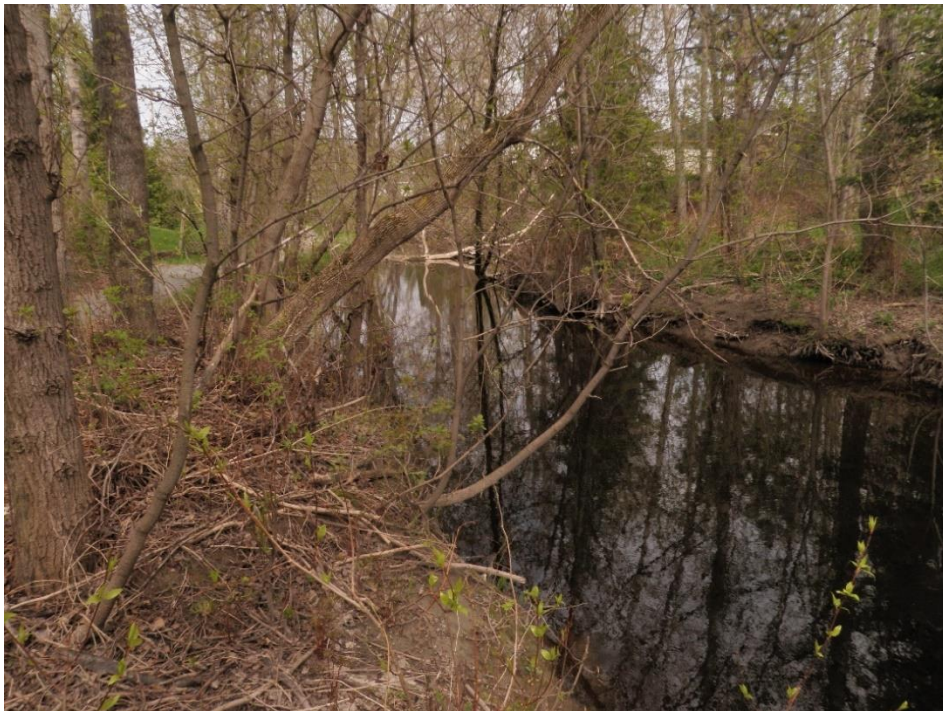
Photo
18
Reach
J16

Photograph taken facing downstream/ right bank.
Leaning trees and bank failure common. Exposed tree roots observed.

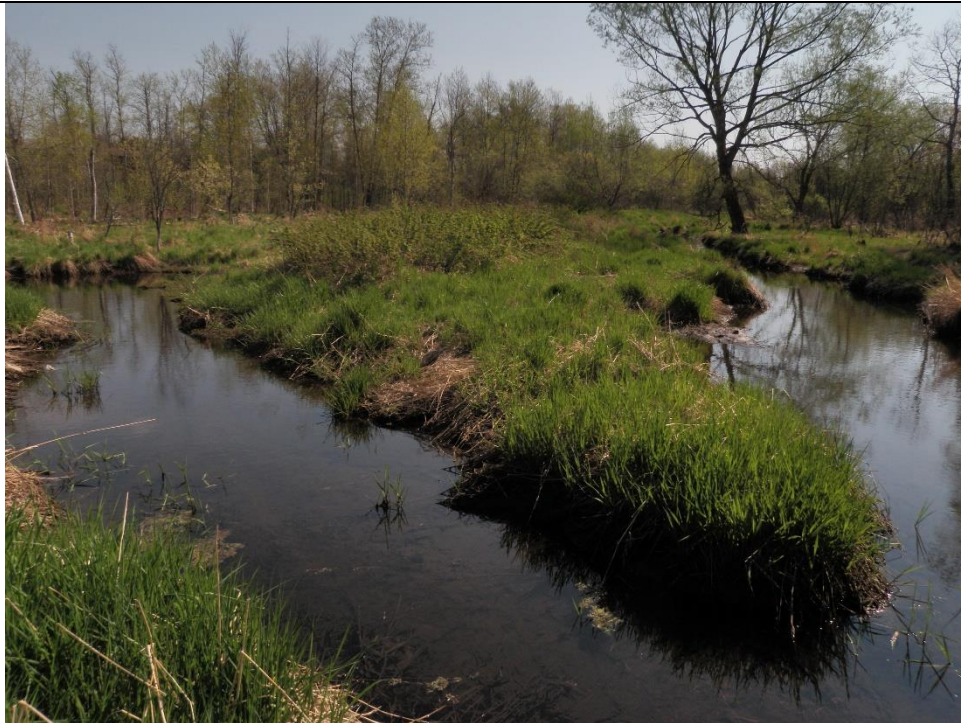
Photo
19
Reach
J17

Photo taken facing downstream to the left.
Mild undercutting and rooted emergent vegetation observed.

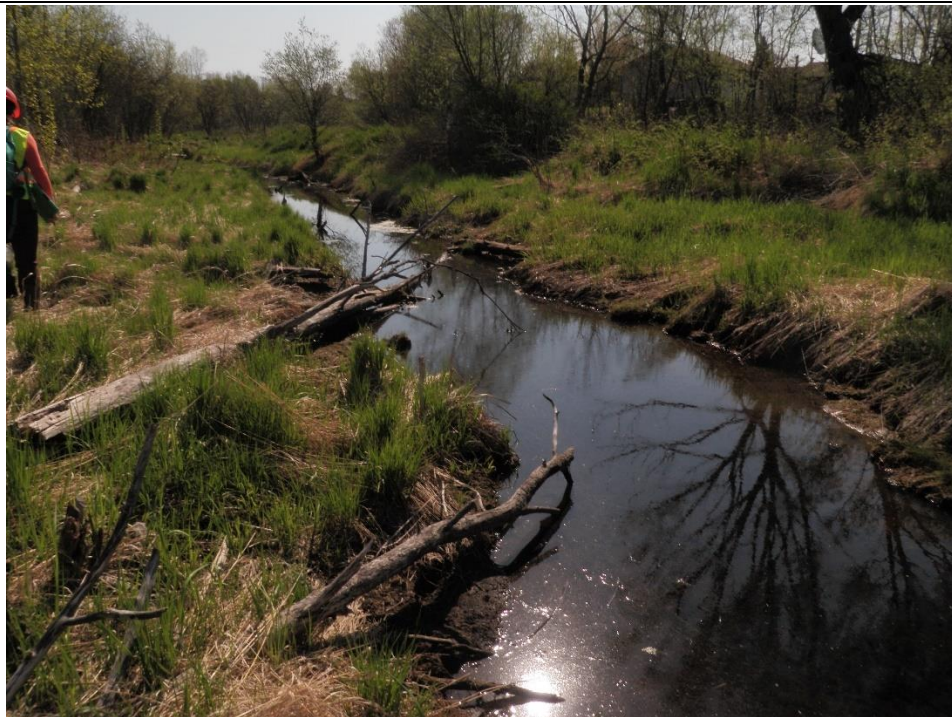
Photo
20
Reach
17

Photo taken facing downstream.
Mild bank erosion and large woody debris observed.

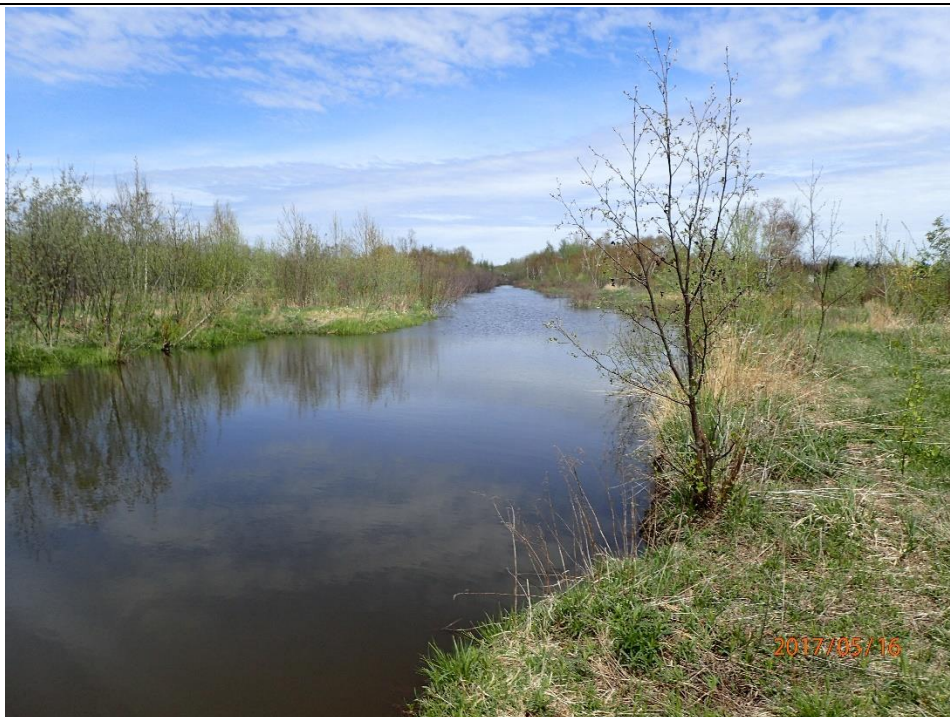
Photo
21

Photograph taken facing upstream.
Extensive backwatering from established beaver dams observed in lower half of reach.

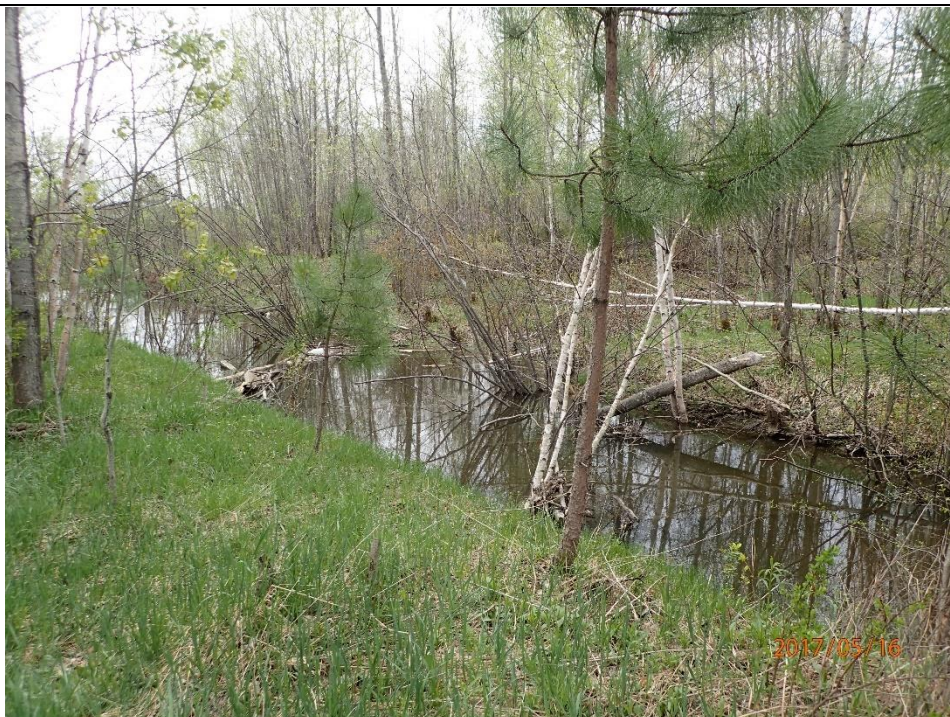
Photo
22

Photograph taken facing downstream.
Backwatering and leaning trees observed along top portion of reach.

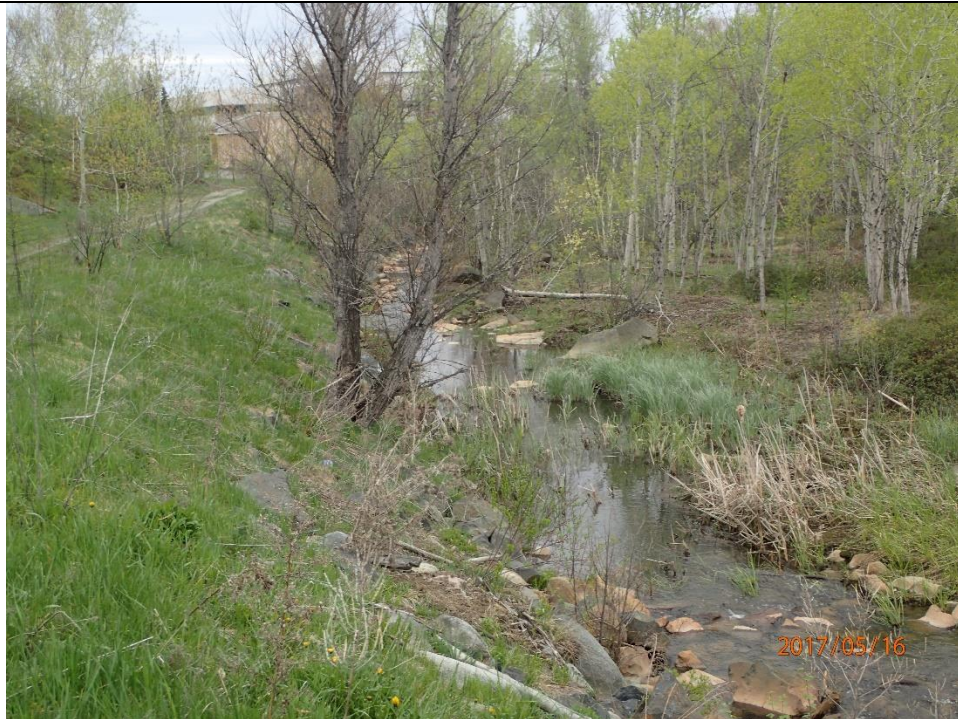
Photo
23

Photograph taken facing downstream.
Large cobbles and boulders in riffles, rooted emergent vegetation observed.

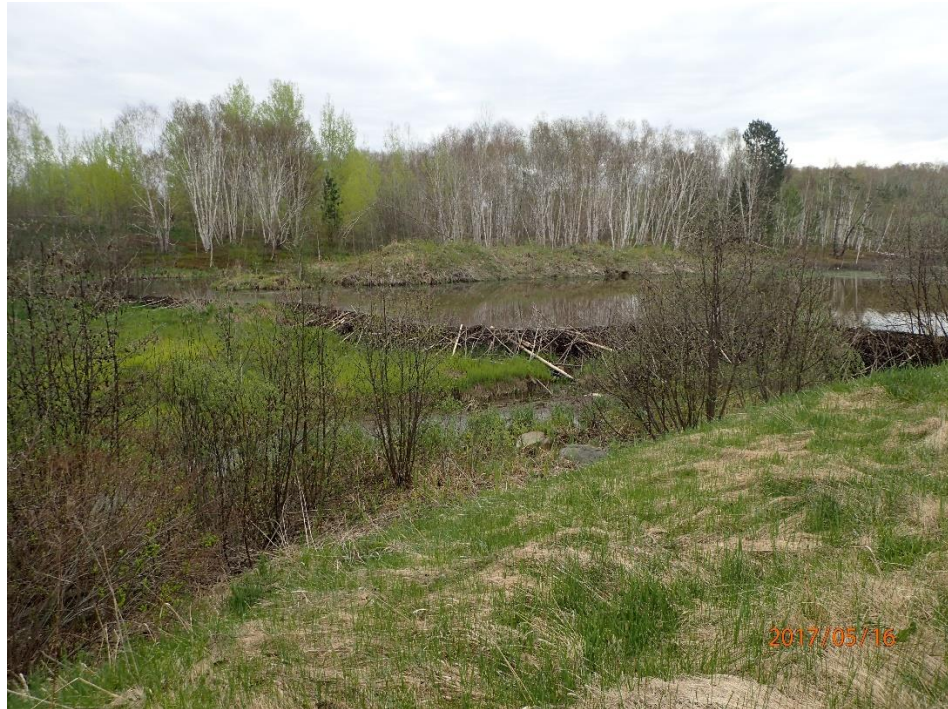
Photo
24

Photograph taken facing upstream.
Extensive backwatering observed upstream of large beaver dam.

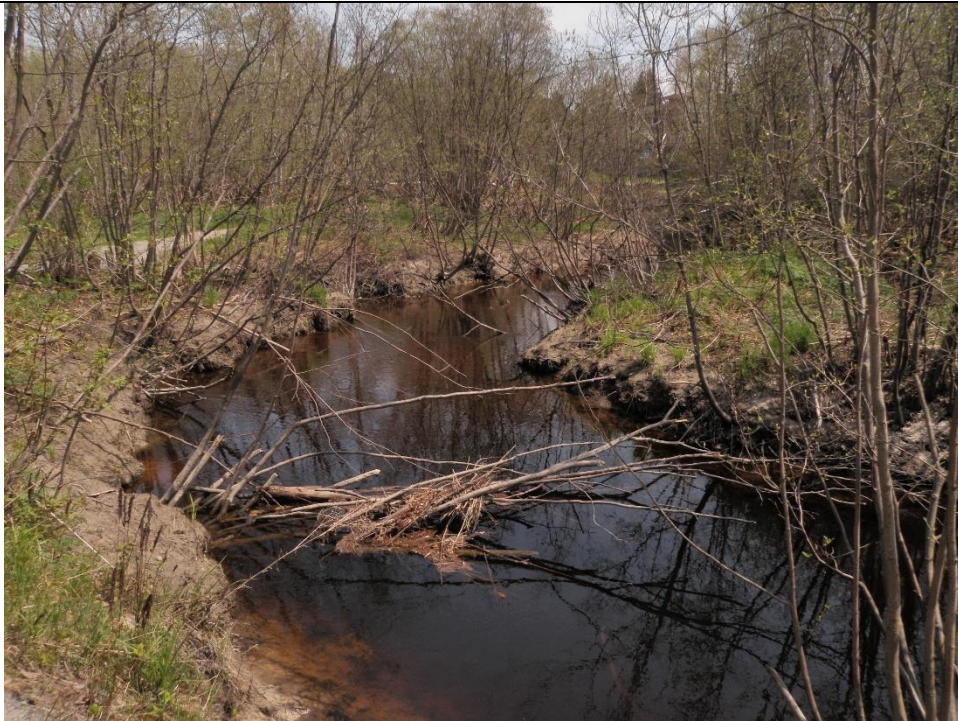
Photo
25
Reach
TJ17

Photograph taken facing downstream/ left bank.
Undercutting and slumping, leaning trees, large woody debris in channel common.

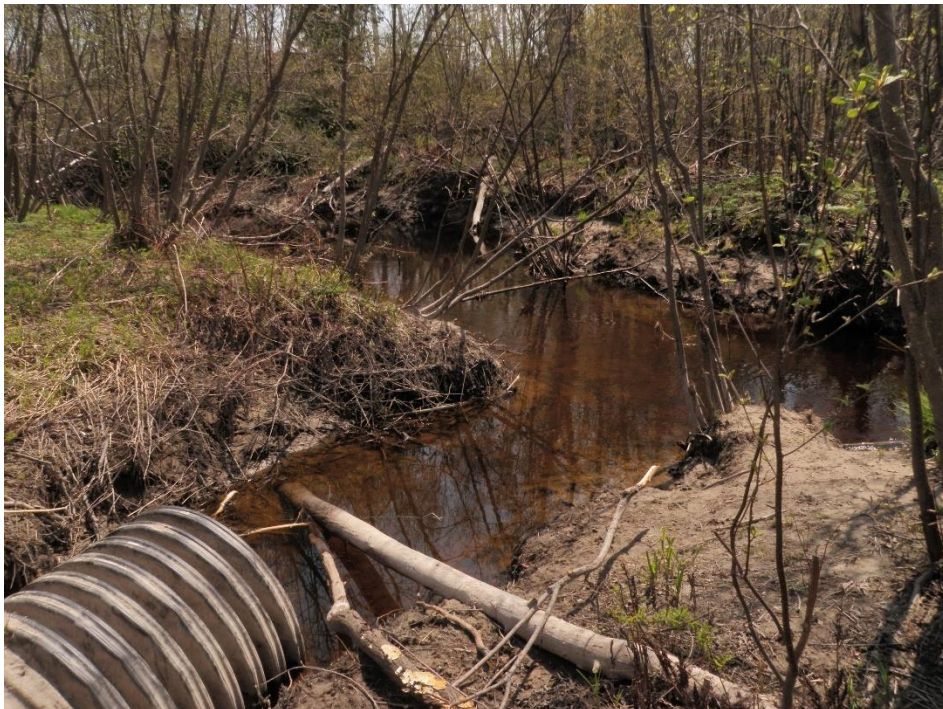
Photo
26
Reach
TJ17

Photograph taken facing downstream toward right bank.
Pipe outlets common throughout reach. Failure and erosion of right bank observed.

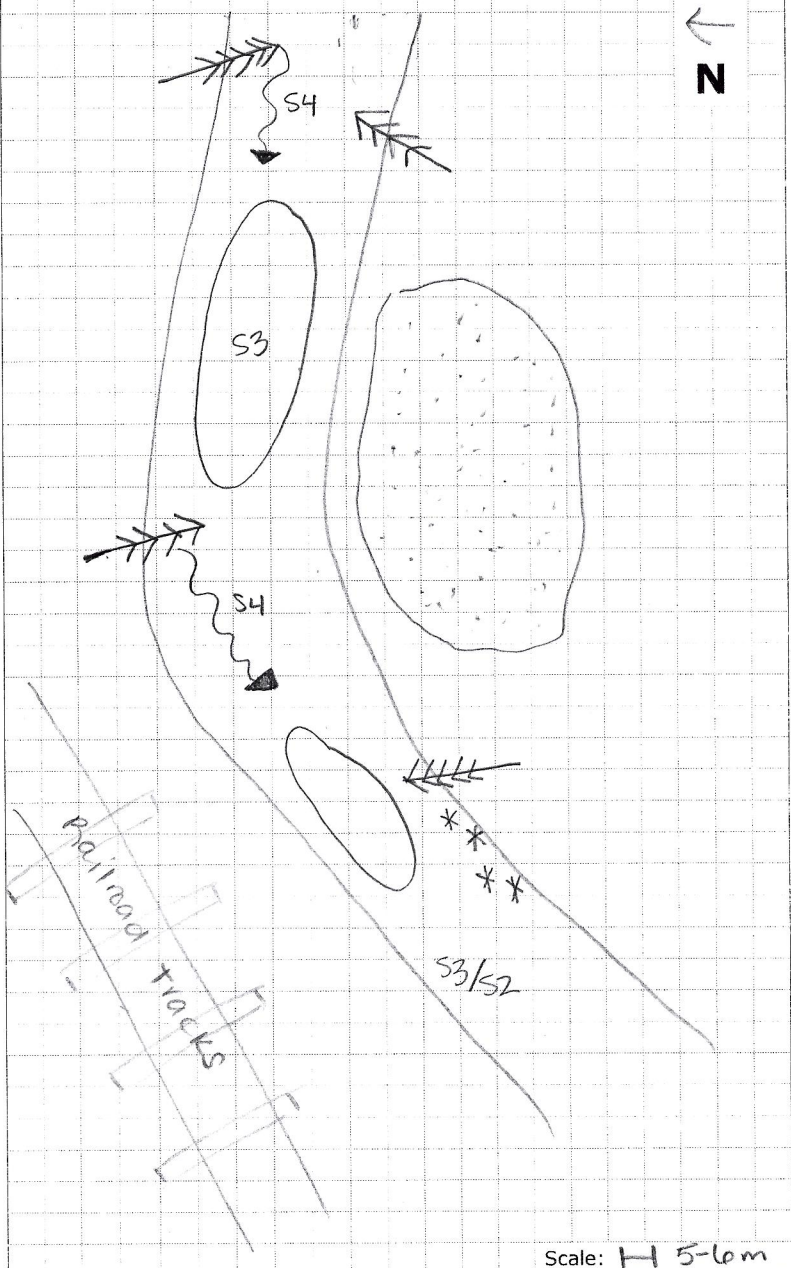
Site Sketch:

Only 2 riffles in the whole reach
