Mid Stream Assessment Technique

Project Code: PN16107

Junction Creek Subwatershed Study Preliminary Reach Delineation

Detailed Geomorphological Assessment Summary

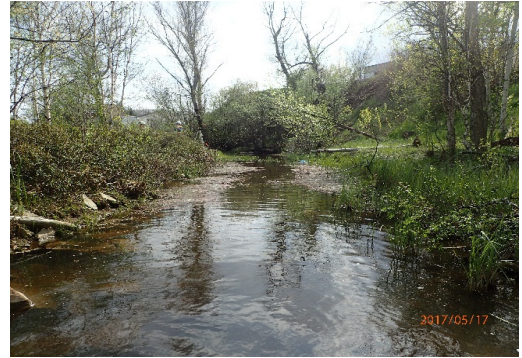
Photograph at cross section 7 (looking downstream)

The reach meanders through a confined valley with a bedrock knob mid-survey. Average bankfull depth and width were 5.66 m and 0.46 m, respectively. Bank erosion was noted along the edge of the parking lot along the right bank. Bank material mainly ranged from silt to gravel with some riprap observed throughout. The downstream section of the survey was mainly a long riffle. Riffle material ranged from sand to large boulders. A long pool was observed upstream of the bedrock knob. Pool material consisted of sand, gravel, and small cobbles.

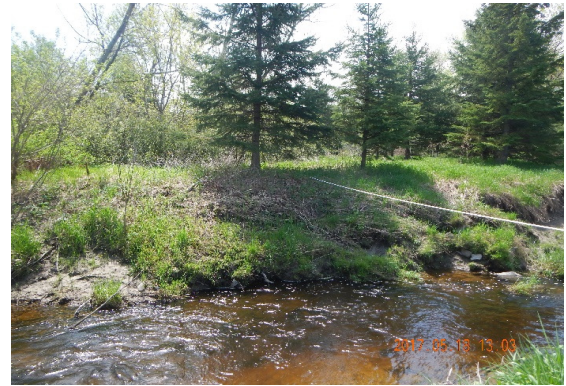
Photograph at cross section 2 (looking at the left bank)

This reach meanders through a residential and commercial area with a moderate gradient and sinuosity. This reach generally had more runs and pools with few riffles. The detailed assessment was completed where riffle features were available. Average bankfull width and depth were 7.8 m and 0.9 m, respectively. Bank erosion was evident and undercuts up to 0.20 m were measured. Slumping and leaning trees were also present. Bank material consisted of silt and sand. Riffle materials ranged from gravel to boulders. Pools consisted mainly of sand.
